Saunton Sands Hotel

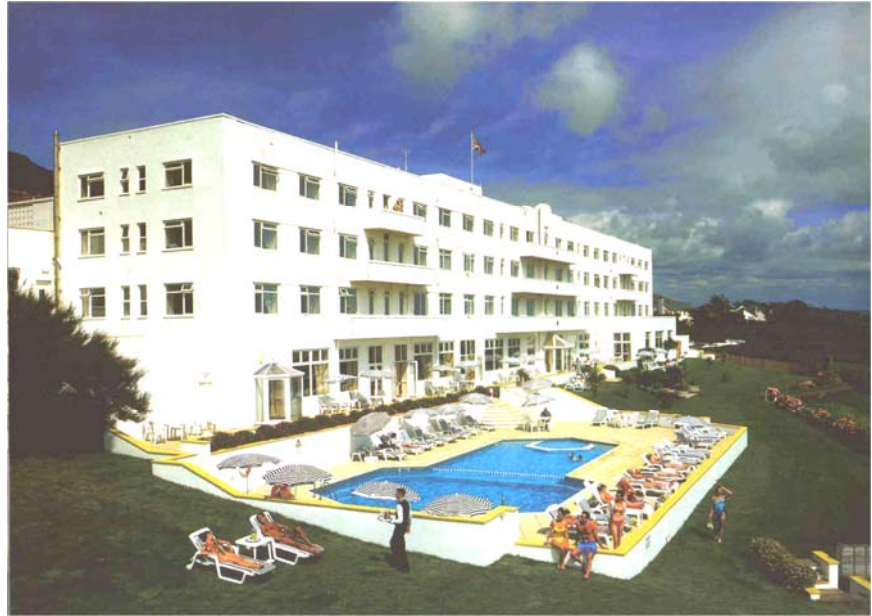
This delightful hotel that commands a wonderful view over Saunton Sands Bay in Devon, had reported regular failures of its water heaters through corrosion brought through its use of 'soft' water off Exmoor. Often the water carried with it vegetative debris which collected in the water heaters that then stained the water supply with a brownish deposit which was evident in the rooms.

The water heaters lasted for about 2 to 3 years and their efficiency declined as the debris increased which also coated the internal surfaces in the heaters. The heat transfer surfaces became hotter as the flame energy could not easily be transferred into the water and welds joining the cylinder floor to the cylinder walls crystallised and fractured, resulting in rusty water dripping onto the plant room floor.

The non-chemical solution was to use a physical cathodic corrosion protection device which was fitted onto the 'make-up' water line to the water heaters. This stopped all the steel of the water heaters being attacked by the soft water. The surface electrolytic currents that occur with corrosion between metals, itself stimulated by the soft water, had been referred it to a sizeable zinc anode within the KorrosionGUARD product, which was designed to be sacrificed instead. A large commercial filter was also fitted to eliminate the vegetable matter to

eliminate the water staining issue.

The water heaters now work as they should with life increased to their commercial expectancy and the water colour effect has been removed, leaving the hotel with a clean usable supply for its occupants.
