**Site : Notton House School, Notton, Nr Chippenham,
Bristol City Council**

Notton House School

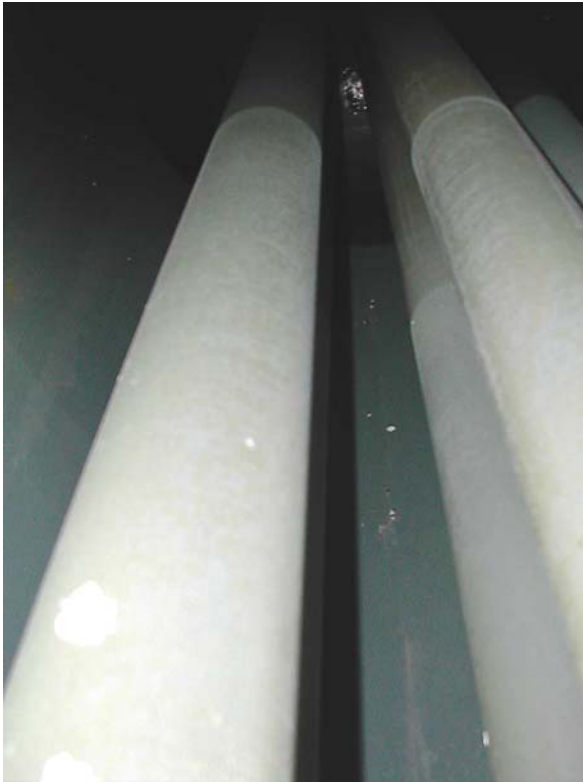
On inspection, the water heaters appear to have a vitreous enamel inner coating on the walls. Where it would have been expected to see significant limescale build-up after only 6 months of operation at this site, this time there was only a little limescale attached to any surface. A few small pieces were on the inner flue pipes (see photo below).

Virtually clean flues

The particles appeared to be minute limescale pieces that have eroded from older limescale deposits and is typical of that seen in other installations. This comes from the hot water recirculating pipework and is showing that the existing limescale is breaking down and then being moved on by the pumped flow until it finds a place of quieter water where it settles out, being the water heater main tank. This is expected to happen for the next few months when it will then stop, confirming the HWS pipework will then be clear of limescale.

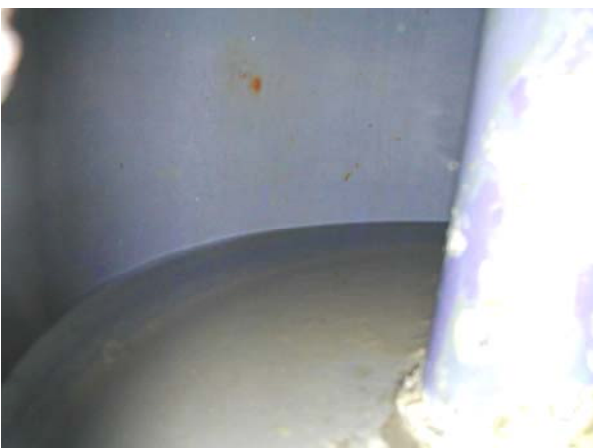
The domed bottom heat transfer surface had quite a collection of what is best described as a sandy silt. This was then flushed out with a hose to the drain off point and leaving a clear inner surface. This silt was later determined to be residue from the HWS pipework system that had collected in the heaters.

The water heater were then cleaned. This was then simply performed by using a hose. No brushes were used and the sediment was flushed out through the drain point. Subsequently, we took new photos (shown here) and the water heater is shown to be clear of limescale and the main heat transfer surface was effectively clean.

Main heat exchange surface seen to be clean

It is estimated that life expectancy of the water heaters will be about 8 to 10 years now, rather than half this time previously experienced. This is giving a significant reduction in asset expenditure at the school. In addition, as limescale deposits build up, water heaters loose 7½% heater efficiency for every 1 mm of scale. On this site, the heaters would have been loosing 25% with the serious limescale previously experienced. This installation now has water heaters working at 100% of manufacturers claimed efficiency and is potentially saving the School about £500 a quarter in gas expenditure. The rapid 'pay back period' for the KalGUARD+ unit means that it pays for itself within 12 months.
